ASSESSMENT OF AIRCRAFT COATING RESISTANCE TO LIGHTNING STRIKES

Matúš Sudin

Pavol Pecho

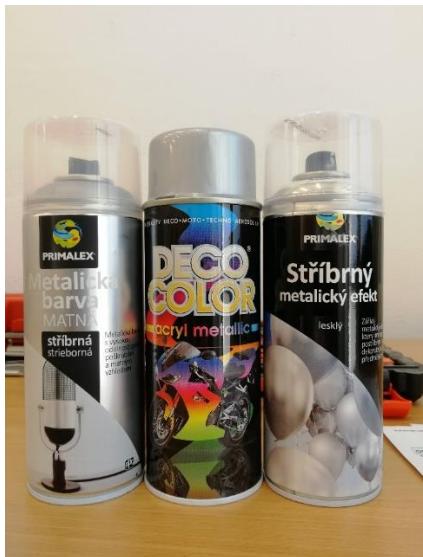
Figure 3: Upper metallic coatings sprays. Source: Authors.

As was mentioned, for experiment was used non-aviation paint for this type of coating, but we tried to simulate it on paints which are free to buy in stores. On Figure 3 are the samples of metallic spray colors. They are usually used in homes or they are used for covering damaged parts on cars or motorcycles. For experiment was chosen two Primalex samples, but one is glossy and the second one is matte. Last one is Decocolor which is glossier than color from Primalex.

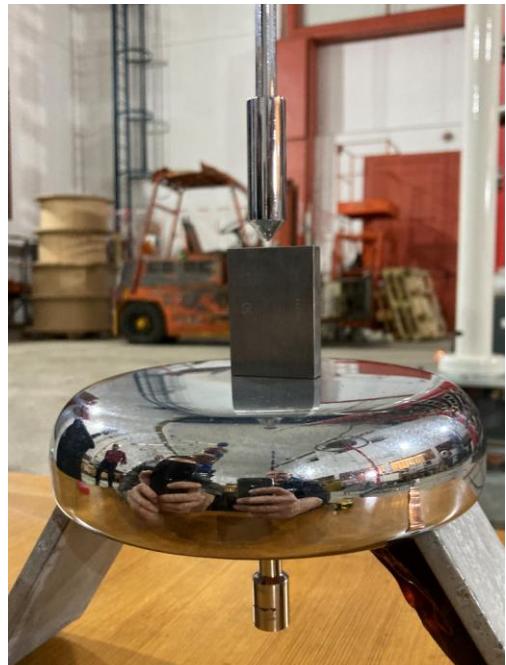
Figure 6: Workplace view. Source: Authors.

impulse generator were connected. For measuring purposes an impulse voltage divider from Haefely-Trench RCR 400 (serial no. 554381-2), digital measuring instrument DMI 551 (serial no. 081 393-03), digital oscilloscope Tektronix TDS3052C (serial no. TDS3052C C011754) and a notebook computer with Tektronix SignalExpert software installed were used.

To every sample a set of 10 negative lightning impulses with shape of 1,2 / 50 μs at maximum voltage level of 100 kV_{\max} were applied.

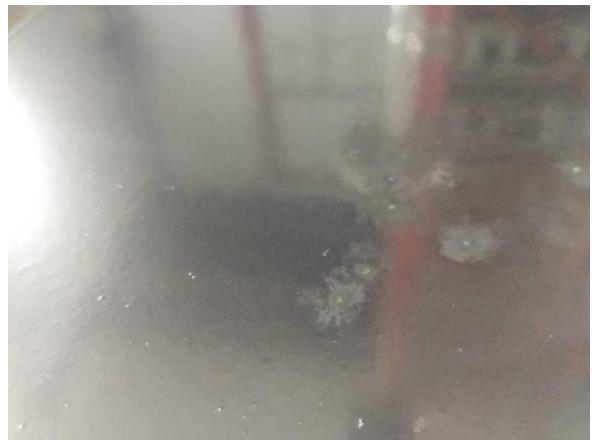
Figure 9 Metallic Primalex gloss coating on PR143-KBHU before and after hit by discharge. Source: Authors.

The metallic parts were a lot of different. Discharge strength was still same as on non-metallic about 100kV. On the first sign we can observe a different between metallic and non-metallic samples.
