THE MAJOR CHALLENGES FACING SLOVAK ROAD AND RAILWAYS INFRASTRUCTURE: CURRENT CONDITIONS, ADMINISTRATION AND PRIORITIES

MICHAL MIŠKE, LUCIA FIGULI

ABSTRACT: The aim of the paper is to assess the current condition of bridges in Slovakia with an emphasis on two key determinants: the ownership and administration of structures and their structural health condition. The study combines official data from the Road Database of the Slovak Road Administration (SSC), available information from the Slovak Railways (ŽSR), findings of the Supreme Audit Office of the Slovak Republic (NKÚ SR), and analytical outputs of the Value for Money Division (UHP). The paper presents an analysis of data related to ownership, administration, categories of current health condition, and accompanying documentation, providing a transparent overview of where the highest risks are concentrated. These infrastructures were identified for the purposes of the REMAKE 3D project. As part of this project, several activities were undertaken to collect information and data; however, such information is often inaccessible or does not exist. The paper includes details about bridge ownership based on a comparison of owner dat

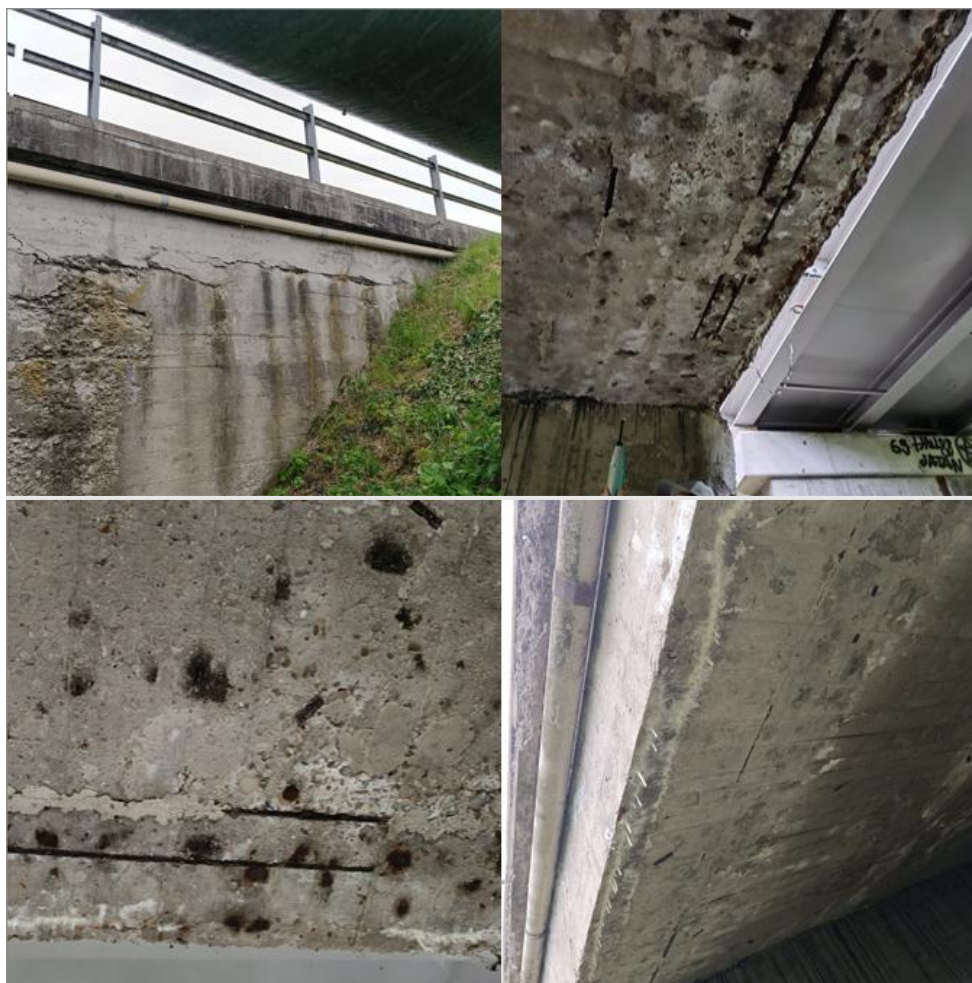
Figure 3 Defects on bridge M7441 (Figuli 2025)

For bridge M7441 specifically, priority actions include targeted material identification (cores with chloride profiling and carbonation depth), verification of reinforcement from GPR, bearing and joint assessment, and an updated load rating. Preventive measures should favour incremental, cost-effective interventions localized concrete repair and re-alkalisation where feasible, cathodic protection or corrosion inhibitors on high-risk zones, waterproofing and drainage upgrades, and deck surfacing improvements before committing to major capital works. This staged approach preserves safety, extends service life, and optimises limited budgets (Alonso 2023). A BIM model was also created for bridge M7441, as the available documentation was outdated and lacked sufficient technical detail. BIM is widely used today and offers numerous applications throughout the project lifecycle.
